Surface Geosciences (Hydrology–Hydrogeology)

# Efficiency of contour benches, filling-in and silting-up of a hillside reservoir in a semi-arid climate in Tunisia

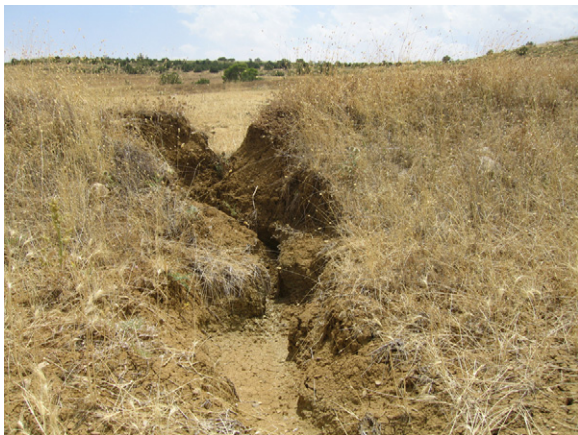
Fig. 6. Example of a breach on a contour bench at the El Gouazine catchment area.

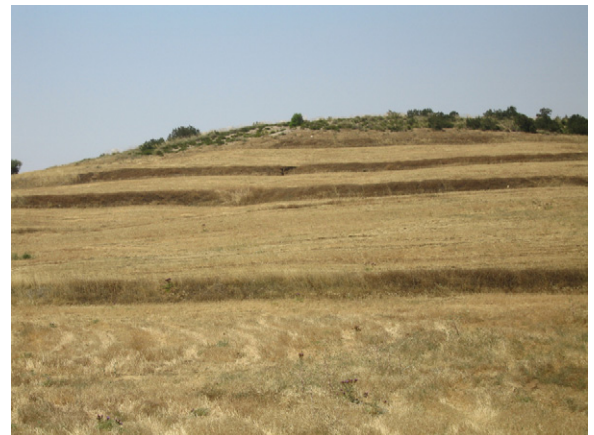
Fig. 7. A cascade of contour benches on a marly slope in the El Gouazine catchment area.

of the benches by taking into account, on the one hand, the runoff capacity of the impluviums and, on the other hand, the soil susceptibility to erosion. Given no breakage, soil erosion in fact influences the life span of the works by a gradual filling-in of the upstream canals of each bench. For those benches located upstream, extra special care must be taken for impluvium size or for treatment against erosion and runoff, since rupture of these upstream benches can lead to a series of breaks (Fig. 7) on the benches located downstream of them.
