Internal Geophysics  
Using the ground-penetrating radar to assess the conservation  
condition of rock-art sites

**Keywords:** Ground-penetrating radar; Rock-art; Conservation; Geophysics; South Africa

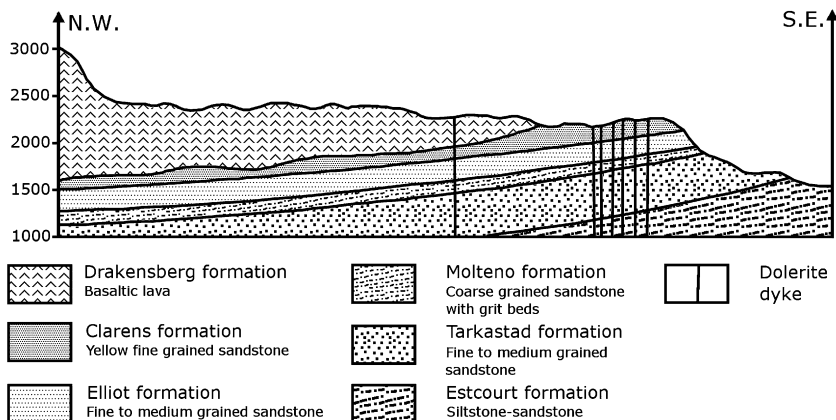
Fig. 5. NW–SE Geologic section of the Drakensberg, perpendicular to Game Pass Shelter scarp (from [17]).

of the Clarens Formation, dated from the Late Triassic (Fig. 5). These sandstones are of aeolian origin, their thickness ranges from 100 m to more than 230 m [14,20], and they are covered, at a regional scale, by important basalt flows dating from the Early Jurassic. Petrographically speaking, the Clarens sandstones are composed of quartz grains, marginally associated with feldspars. They appear as layers of finely sorted sandstones of colours ranging from ochre to rust [8]. Between the layers, there are clay joints of bluish

The Clarens layers are widely fractured, which causes the broken aspect of the principal scarp. In the studied area, the fracturing is mainly oriented  $60^\circ$  from the north and is therefore orthogonal to the orientation of the scarp at GP (mainly comprised between  $120^\circ$  and  $150^\circ$  from the north). The dip of the sandstone layers is relatively low, varying around 3 and 5 degrees to the northwest. This confers a pseudo-tabular and monocline structure to the sedimentary ensemble. The massive structure of the sandstone layers and their natural tendency to break out in metre-large blocks constitute a major risk for the conservation of the sites. This is well evidenced at GP by the accumulation at the base of the scarp of sandstone blocks that can reach about  $50 \text{ m}^3$ .
