Surface Geosciences (Hydrology–Hydrogeology)

# Efficiency of contour benches, filling-in and silting-up of a hillside reservoir in a semi-arid climate in Tunisia

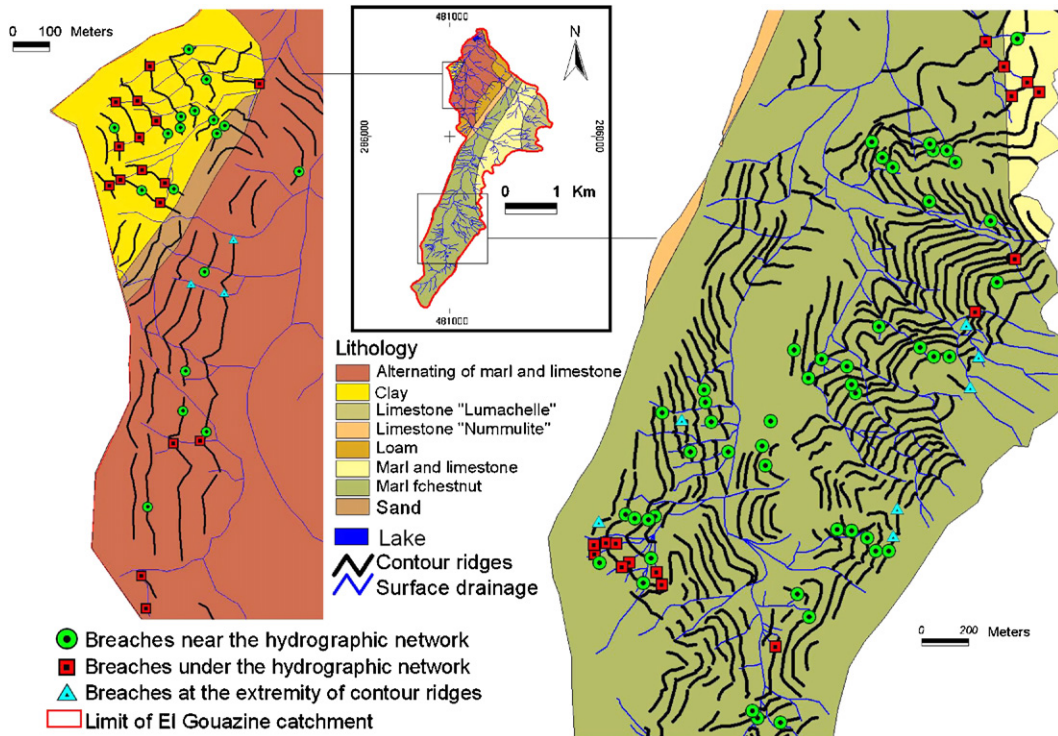
Fig. 4. Lithological map of the El Gouazine catchment area.

(Fig. 4). In El Gouazine, 80% of the observed breaches are thus associated with the layout of the hydrographic network.
