Mechanical characterization of glass/vinylester $\pm 55^\circ$ filament wound pipes by acoustic emission under axial monotonic loading

Ated Ben Khalifa ^{a,*}, Mondher Zidi ^a, Laksimi Abdelwahed ^b

In this article a mechanical characterization of filament wound pipes is investigated. The tested pipes are composed of E glass/vinylester with $\pm 55^\circ$ angle wedding. The mechanical behavior under axial monotonic loading is studied using acoustic emission. The test was carried out according to the instructions of standard ASTM-D 2105-01 test. The experiment determines the damage mode using two methods: acoustic emission and tensile test. The results of acoustic emission associated to those obtained from tensile test, are very promising and show the relevance of the developed nondestructive test to the prediction of the mechanical behavior of filament wound pipes.

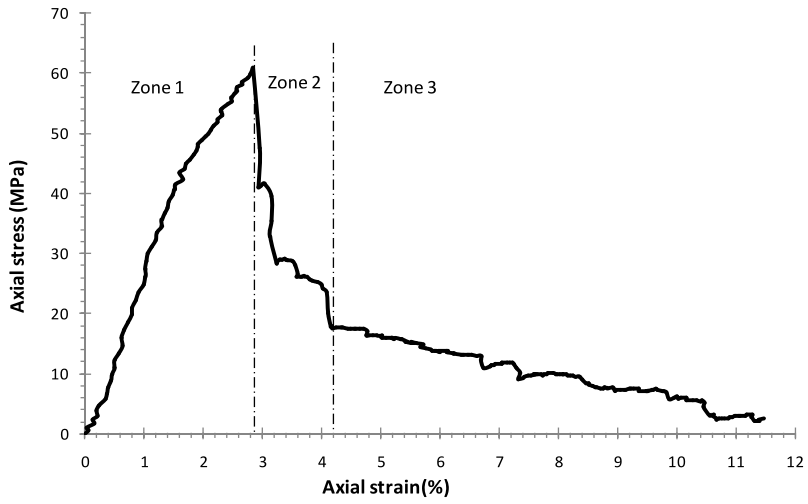
Fig. 4. Stress/strain curves of four glass/vinylester $\pm 55^\circ$ filament wound pipes.

In order to study the mechanical behavior of the glass/vinylester $\pm 55^\circ$ FWP, a stress/strain curve was plotted in Fig. 4. It is noticed that this curve is divided into three zones: The first, linear zone, corresponds to the elastic behavior of the composite material; this linear and reversible behavior is often associated with a material which is not damaged. Thereafter, a progressive transverse cracking in the matrix starts. This phenomenon is observed in the outer skin of resin. A second zone (noted by Zone 2), starts from the limit of the first zone: the curve becomes nonlinear and the slope decreases gradually. We observe a pronounced peak at an axial stress of about 60.77 MPa and an axial strain of about 2.83%. This zone is associated to the matrix failure. The last, third zone (noted by Zone 3), is associated with a continuous accumulation of the individual fiber failure which involves the failure of the fiber bands on the surface of the FWP and leads to the total damage of the FWP. Fig. 5 shows a damaged tube after an axial monotonic loading.
